**Flood Control Project Maintenance
Levee Inspections**

2018 Channel Summary Report

Fairfield Suisun Sewer District

Flood Control Project Maintenance**Unit Cover Sheet****2018 Channel Inspection Results****Fairfield Suisun Sewer District**

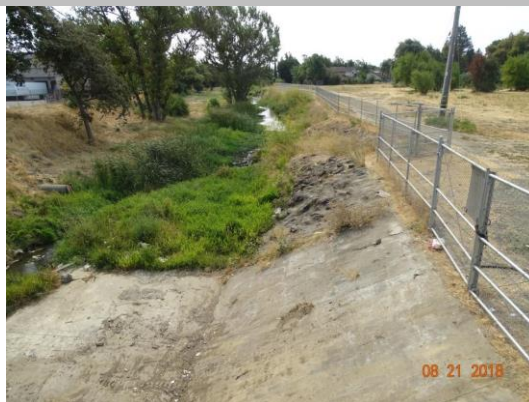
Photo 1 of 5 : CH_2018_NA0035_17_36_20180823_00066.jpg

Check Point / View				
Auto Mall Parkway / Down				
Rating **	A	Issue No.	36	GPS Lat/Long
Issue Type +	Ma	Location *		38.247722 °
Category	Rivers, Channels & Designated Flood			-122.072105 °
Item	Vegetation & Obstructions			
DWR ID	DWR_NA0035_17_c_2012_36			
Action/Comments				
Inspector Comments: Minimal, scattered obstructions or vegetation. The flow is not impeded.

View of the channel looking downstream. Summer 2018.

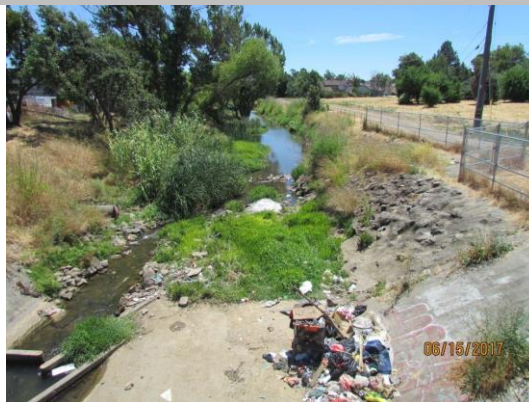
Photo 2 of 5 : CH_2018_NA0035_17_36_20180529_00024.jpg

View of the channel looking downstream. Summer 2017.

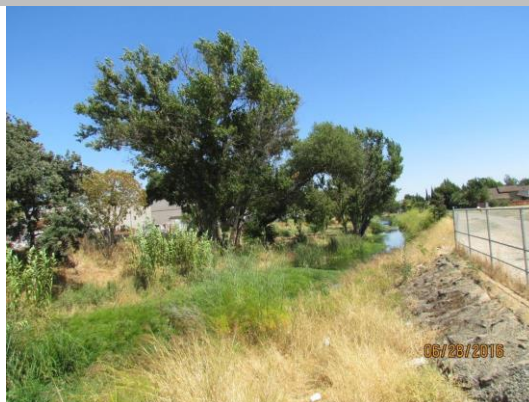
Photo 3 of 5 : CH_2018_NA0035_17_36_20180529_00025.jpg

Inspector Comments: Minimal, scattered obstructions or vegetation. The flow is not impeded.

View of the channel looking downstream from Auto Mall Pkwy. Summer 2016.

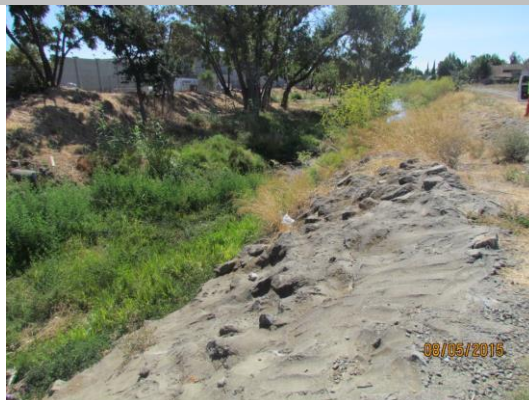
Photo 5 of 5 : CH_2018_NA0035_17_36_20180529_00027.jpg

Looking downstream from Auto Mall Pkwy. Summer 2015.

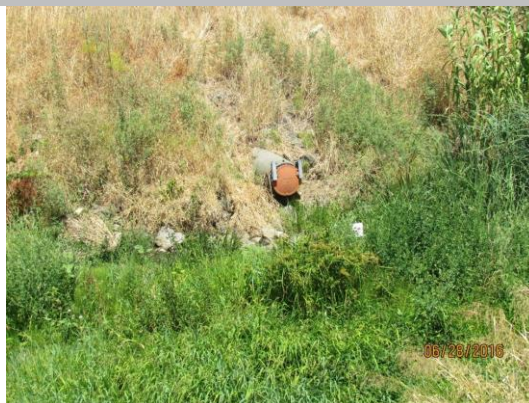
Photo 2 of 3 : CH_2018_NA0035_17_82_20180529_00056.jpg

Inspector Comments: Gates open and close easily with minimal leakage. Gates show no corrosion damage and have been maintained.

View of the gate on the downstream side of the channel from Auto Mall Pkwy. Summer 2016.

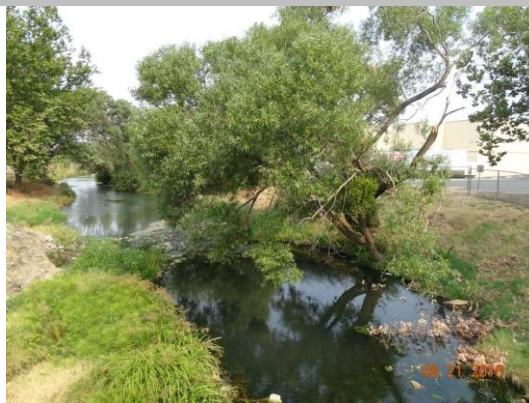
Photo 1 of 4 : CH_2018_NA0035_17_41_20180823_00064.jpg

Inspector Comments: Minimal, scattered obstructions or vegetation. The flow is not impeded.

View of the channel looking upstream. Summer 2018.

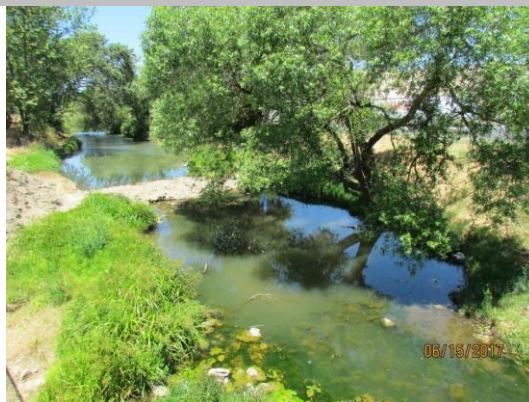
Photo 2 of 4 : CH_2018_NA0035_17_41_20180529_00028.jpg

Inspector Comments: Minimal, scattered obstructions or vegetation. The flow is not impeded.

View of the channel looking upstream. Summer 2017.

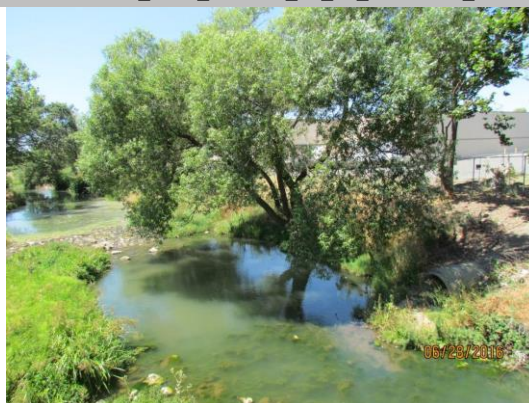
Photo 3 of 4 : CH_2018_NA0035_17_41_20180529_00029.jpg

View of the channel looking upstream from Woolner Ave. Cart has been removed. Summer 2016.

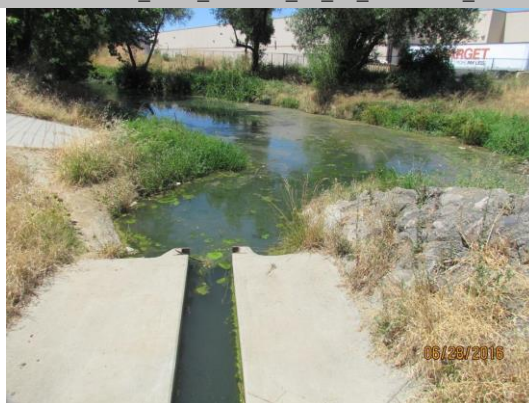
Photo 4 of 4 : CH_2018_NA0035_17_41_20180529_00030.jpg

View of the inlet of the historical channel looking upstream from Woolner Ave. Summer 2016.

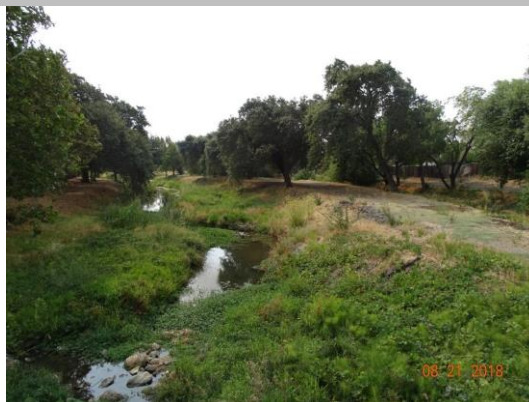
Photo 1 of 5 : CH_2018_NA0035_17_46_20180823_00063.jpg

Check Point / View				
Woolner Avenue / Down				
Rating **	A	Issue No.	46	GPS Lat/Long
Issue Type +	Ma	Location *		38.245298 °
Category	Rivers, Channels & Designated Flood			-122.068536 °
Item	Vegetation & Obstructions			
DWR ID	DWR_NA0035_17_c_2012_46			
Action/Comments				
Inspector Comments: Minimal, scattered obstructions or vegetation. The flow is not impeded.

View of the channel looking downstream. Summer 2018.

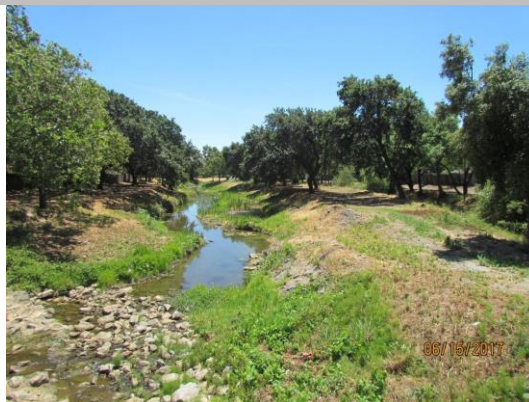
Photo 2 of 5 : CH_2018_NA0035_17_46_20180529_00032.jpg

View of the channel looking downstream. Summer 2017.

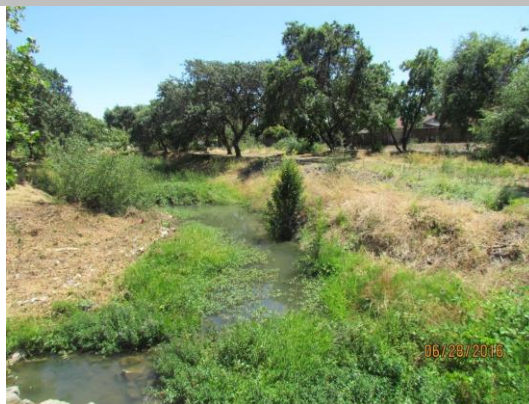
Photo 3 of 5 : CH_2018_NA0035_17_46_20180529_00033.jpg

Inspector Comments: Minimal, scattered obstructions or vegetation. The flow is not impeded.

View of the channel looking downstream from Woolner Ave. Summer 2016.

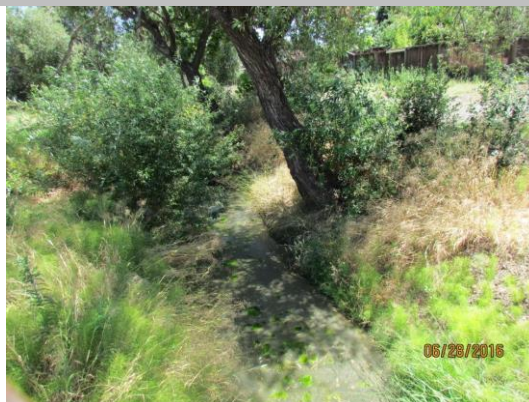
Photo 4 of 5 : CH_2018_NA0035_17_46_20180529_00034.jpg

Looking at the downstream side of the historical channel from Woolner Ave. Summer 2016.

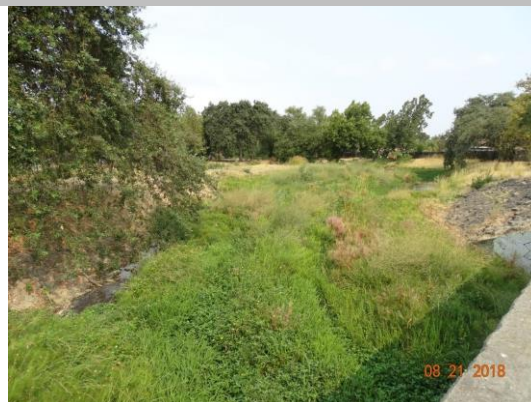
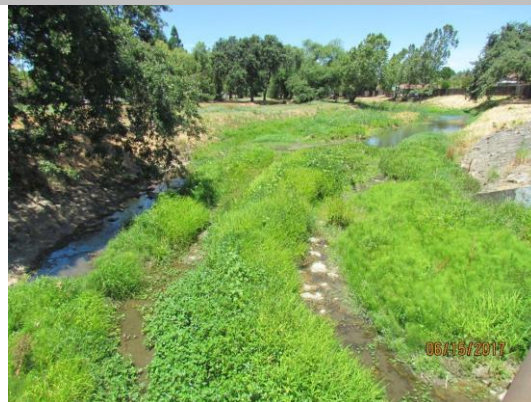
Check Point / View				
Beck Avenue / Up				
Rating **	A	Issue No.	51	GPS Lat/Long
Issue Type +	Ma	Location *		38.243683 °
Category	Rivers, Channels & Designated Flood			-122.066470 °
Item	Vegetation & Obstructions			
DWR ID	DWR_NA0035_17_c_2012_51			
Action/Comments				
Inspector Comments: Minimal, scattered obstructions or vegetation. The flow is not impeded.

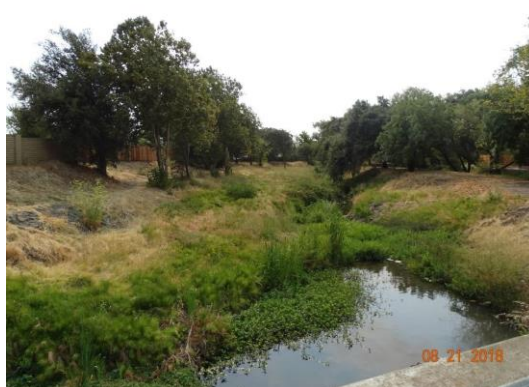
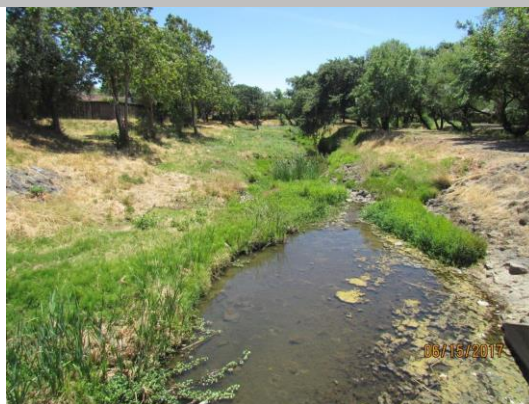
Inspector Comments: Minimal, scattered obstructions or vegetation. The flow is not impeded.

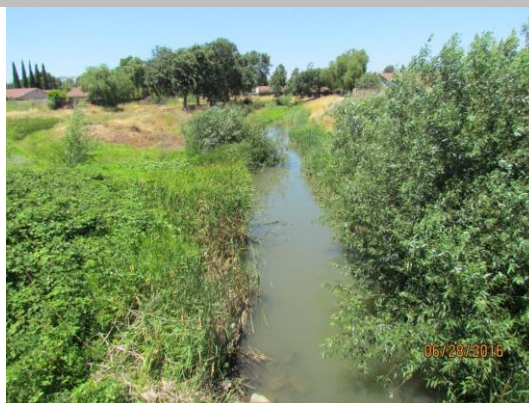
Photo 3 of 4 : CH_2018_NA0035_17_61_20180529_00045.jpg

View of the channel looking upstream from Highway 12. Suggest trimming of trees. Summer 2016.

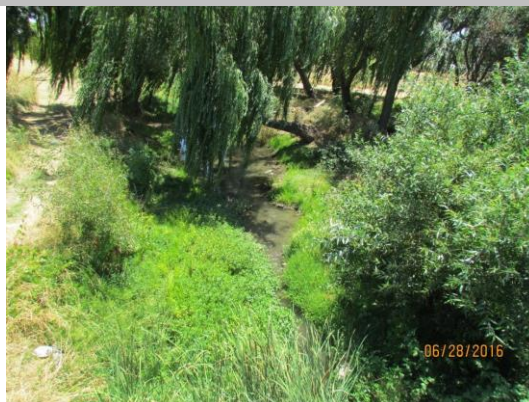
Photo 2 of 3 : CH_2018_NA0035_17_66_20180529_00048.jpg

View of the channel looking downstream from Highway 12. Tree encroaching into channel needs to be removed or trimmed. Summer 2016.

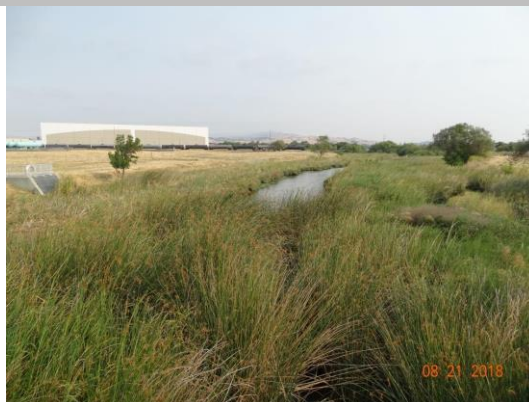
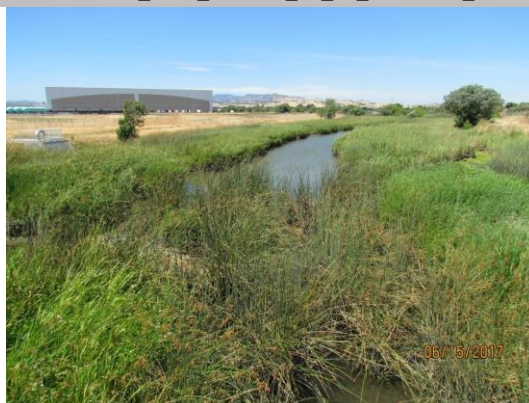
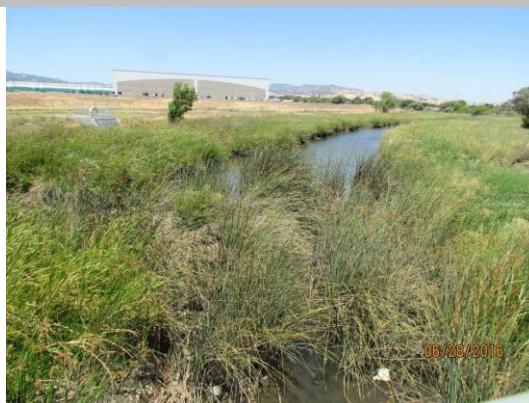
Rating **	M	Issue No.	71 (cont)	GPS Lat/Long
Issue Type +	Ma	Location *		38.233331 °
Category	Rivers, Channels & Designated Flood			-122.058608 °
Item	Vegetation & Obstructions			
DWR ID	DWR_NA0035_17_c_2012_71			
Action/Comments				
Inspector Comments: Vegetation growth of cattails or other obstruction impede the flow.

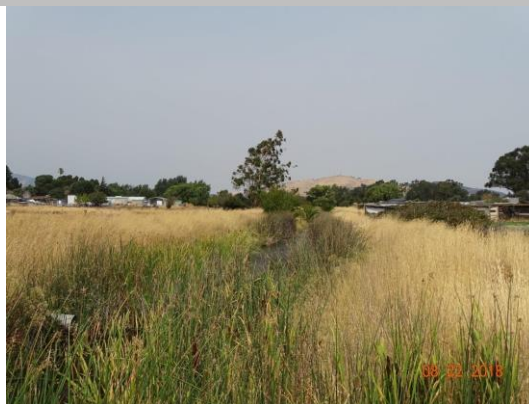
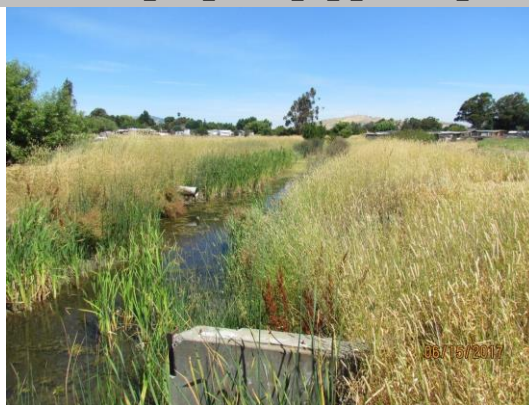
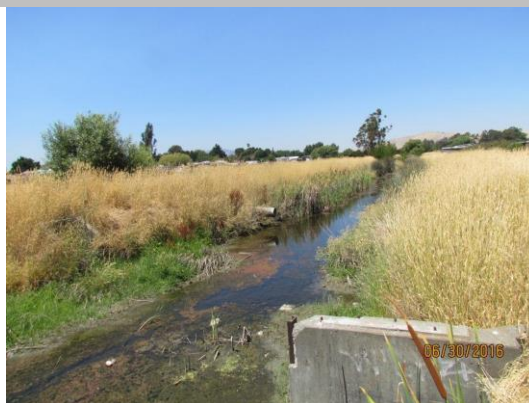
Inspector Comments: Vegetation blocks approximately 25% of the capacity.

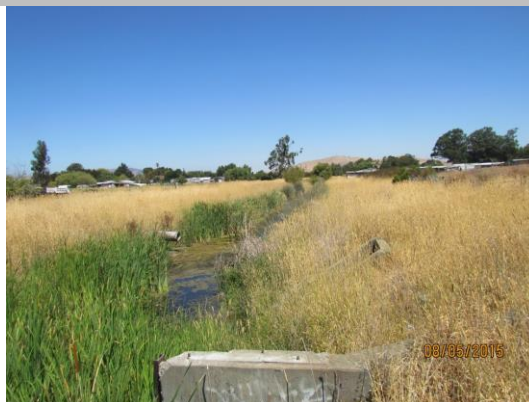
Photo 4 of 4 : CH_2018_NA0035_14_1_20180529_00003.jpg

View of the vegetation looking upstream of the channel. Summer 2015.

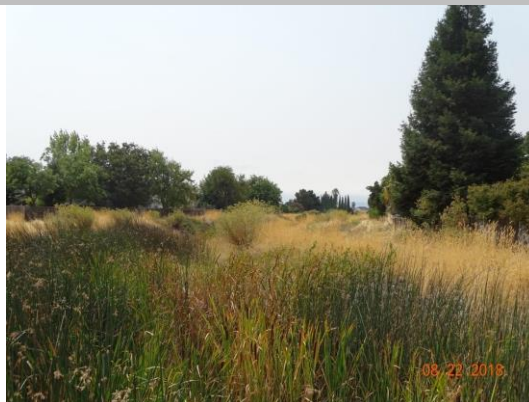
Photo 1 of 4 : CH_2018_NA0035_14_6_20180823_00033.jpg

Inspector Comments: Vegetation growth (such as cat tails, bull rushes, bushes or saplings) or other obstructions block approximately 25% of the capacity.

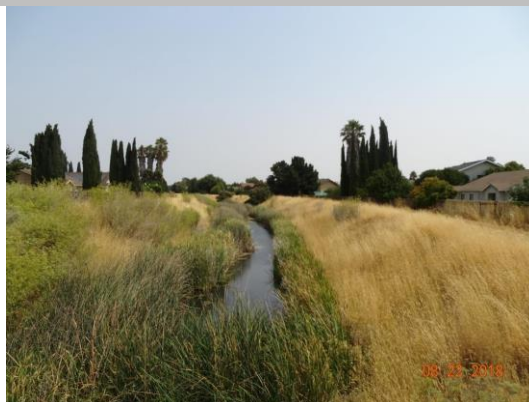
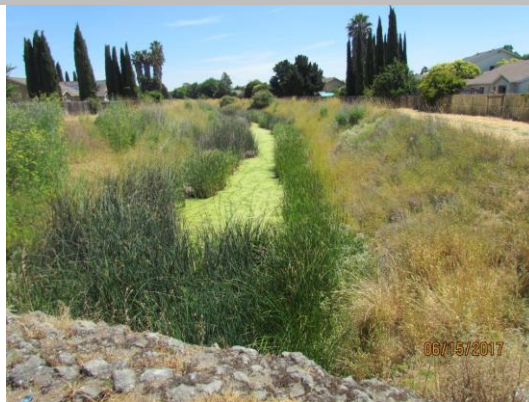
Inspector Comments: Cat-tails need to be sprayed or removed at street crossing.

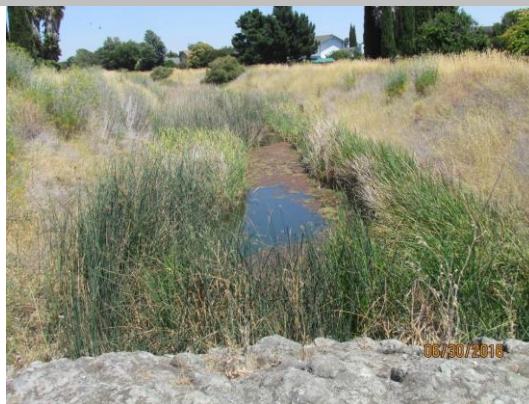
Photo 3 of 4 : CH_2018_NA0035_14_11_20180529_00008.jpg

Inspector Comments: Cat-tails need to be sprayed or removed at street crossing.

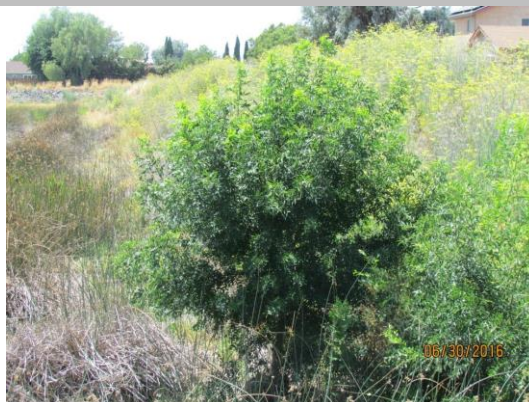
Photo 4 of 5 : CH_2018_NA0035_14_16_20180529_00012.jpg

Inspector Comments: Cattails/bull rush need to be sprayed or removed at street crossing. Try to maintain 50 ft. to 100 ft. clearance. Woody vegetation needs to be removed.

Remove woody vegetation from the creek. Summer 2016.

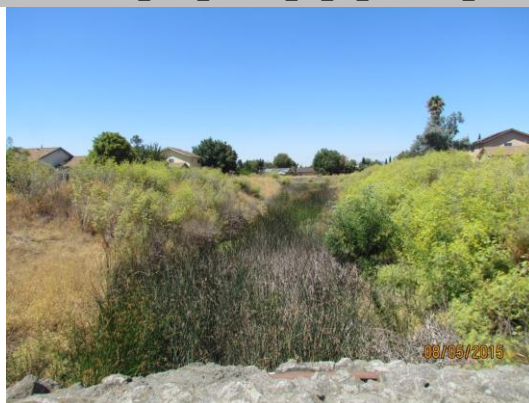
Photo 5 of 5 : CH_2018_NA0035_14_16_20180529_00013.jpg

View of the vegetation looking downstream. Summer 2015.

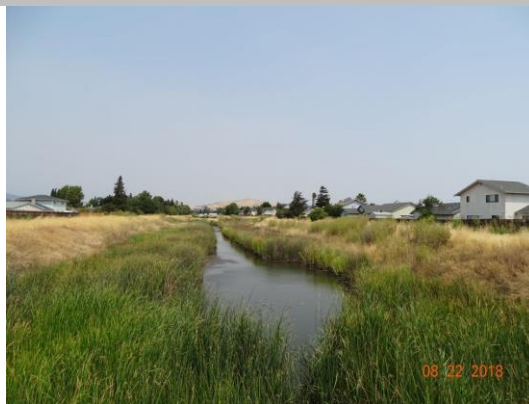
Photo 1 of 4 : CH_2018_NA0035_14_21_20180823_00030.jpg

View of the channel looking upstream. Summer 2018.

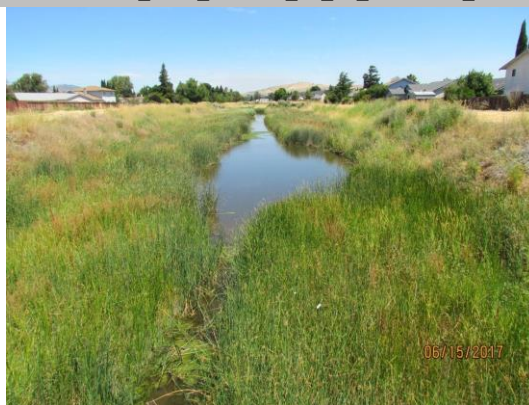
Photo 2 of 4 : CH_2018_NA0035_14_21_20180529_00014.jpg

View of the channel looking upstream. Summer 2017.

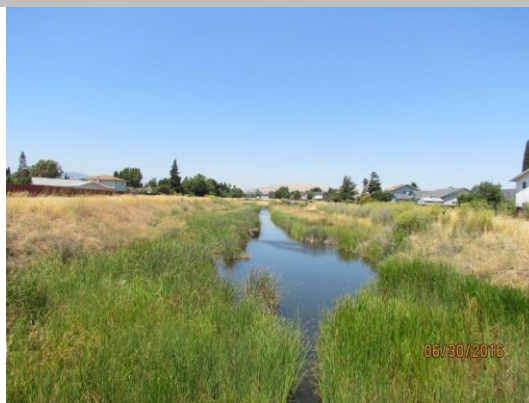
Photo 3 of 4 : CH_2018_NA0035_14_21_20180529_00015.jpg

View of the creek looking upstream from Pintail Dr. Summer 2016.

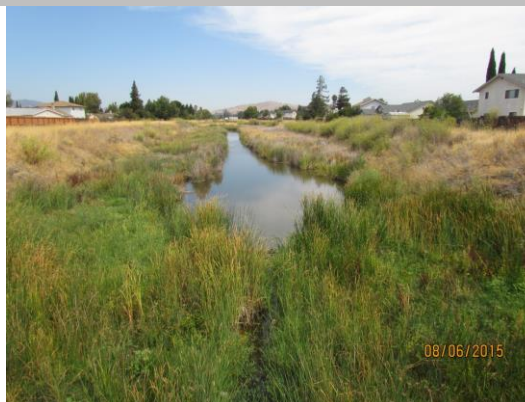
Photo 4 of 4 : CH_2018_NA0035_14_21_20180529_00016.jpg

Rating **	A	Issue No.	21 (cont)	GPS Lat/Long
Issue Type +	Ma	Location *		38.248542 °
Category	Rivers, Channels & Designated Flood			-122.006378 °
Item	Vegetation & Obstructions			
DWR ID	DWR_NA0035_14_c_2012_21			
Action/Comments				
Inspector Comments: Minimal scattered obstruction or vegetation. The flow is not impeded.

View of the channel looking upstream. Summer 2015.

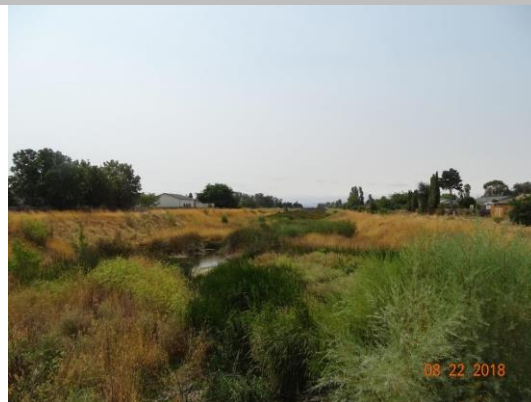
Photo 1 of 5 : CH_2018_NA0035_14_26_20180823_00029.jpg

Inspector Comments: Minimal, scattered obstructions or vegetation. The flow is not impeded.

View of the channel looking downstream. Summer 2018.

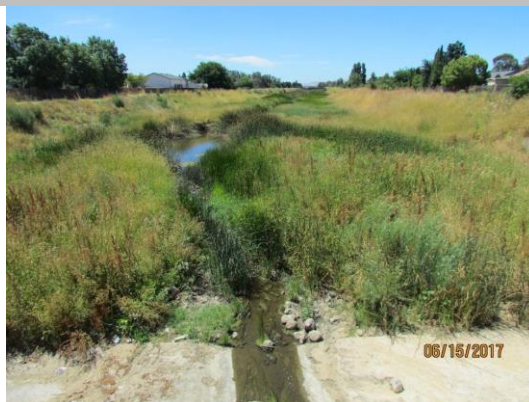
Photo 2 of 5 : CH_2018_NA0035_14_26_20180529_00017.jpg

View of the channel looking downstream. Summer 2017.

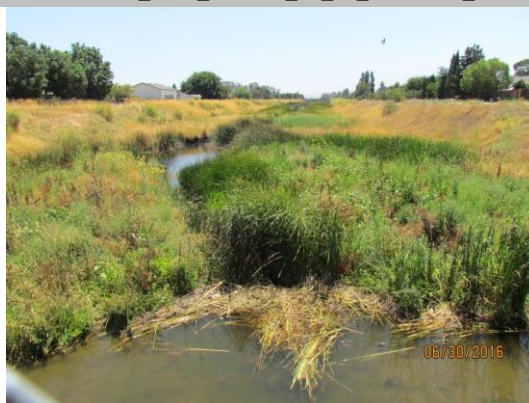
Photo 3 of 5 : CH_2018_NA0035_14_26_20180529_00018.jpg

View of the creek looking downstream from Pintail Dr. Summer 2016.

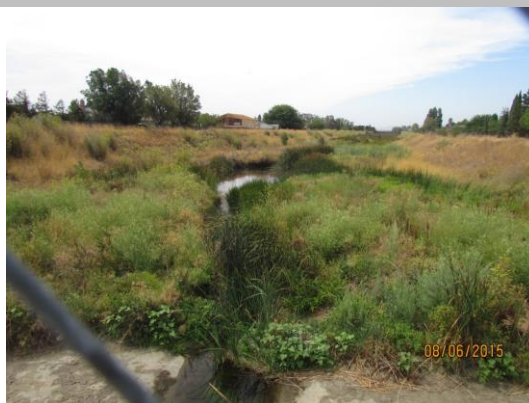
Photo 4 of 5 : CH_2018_NA0035_14_26_20180529_00019.jpg

View of the channel looking downstream. Summer 2015.

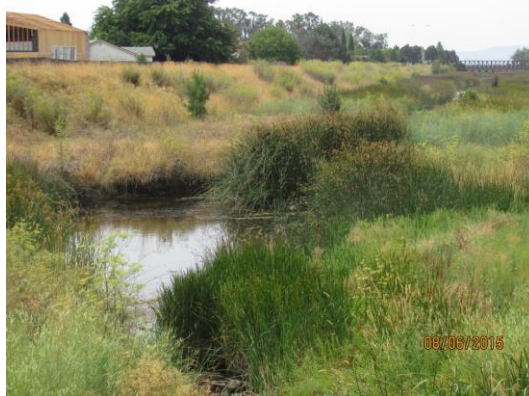
Photo 5 of 5 : CH_2018_NA0035_14_26_20180529_00020.jpg

Rating **	A	Issue No.	26 (cont)	GPS Lat/Long
Issue Type +	Ma	Location *		38.248501 °
Category	Rivers, Channels & Designated Flood			-122.006346 °
Item	Vegetation & Obstructions			
DWR ID	DWR_NA0035_14_c_2012_26			
Action/Comments				
Inspector Comments: Minimal, scattered obstructions or vegetation. The flow is not impeded.

Suggest removal of tullies downstream. Summer 2015.

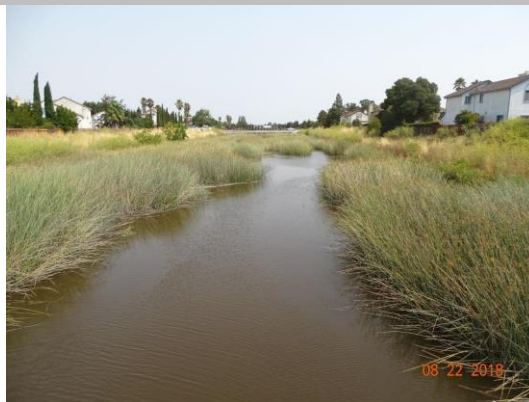
Photo 1 of 4 : CH_2018_NA0035_14_31_20180823_00028.jpg

Inspector Comments: Minimal, scattered obstructions or vegetation. The flow is not impeded.

View of the channel looking upstream. Summer 2018.

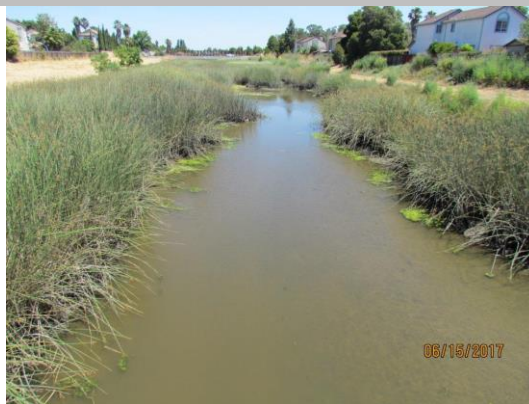
Photo 2 of 4 : CH_2018_NA0035_14_31_20180529_00021.jpg

View of the channel looking upstream. Summer 2017.

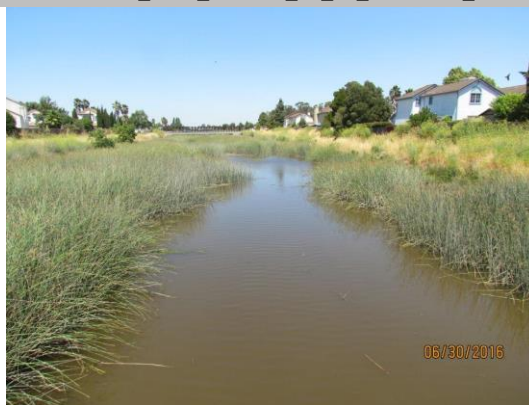
Photo 3 of 4 : CH_2018_NA0035_14_31_20180529_00022.jpg

View of the creek looking upstream from Anderson Dr. Summer 2016.

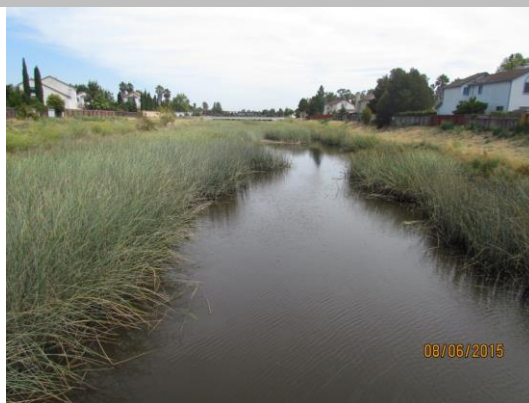
Photo 4 of 4 : CH_2018_NA0035_14_31_20180529_00023.jpg

View of the channel looking upstream. Summer 2015.

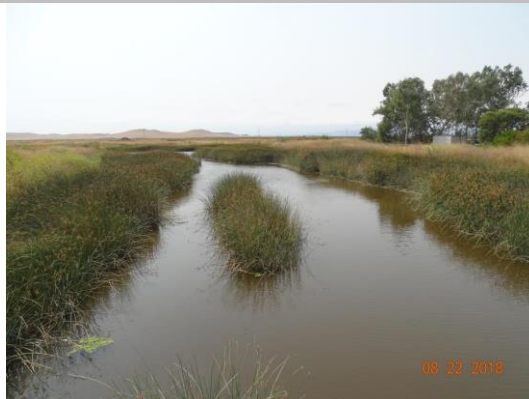
Photo 1 of 4 : CH_2018_NA0035_14_36_20180823_00027.jpg

Inspector Comments: Minimal, scattered obstructions or vegetation. The flow is not impeded.

View of the channel looking downstream. Summer 2018.

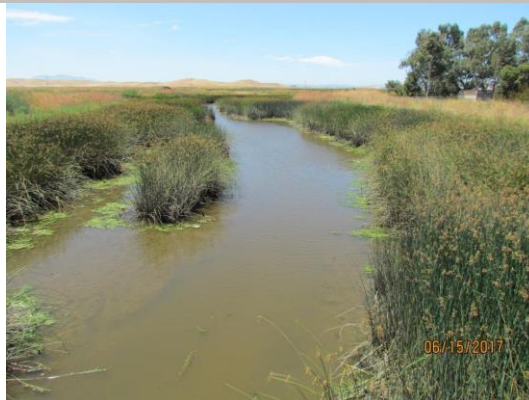
Photo 2 of 4 : CH_2018_NA0035_14_36_20180529_00024.jpg

View of the channel looking downstream. Summer 2017.

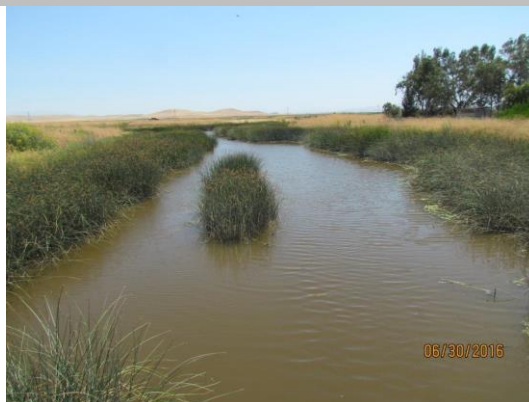
Photo 3 of 4 : CH_2018_NA0035_14_36_20180529_00025.jpg

Rating **	A	Issue No.	36 (cont)	GPS Lat/Long
Issue Type +	Ma	Location *		38.241537 °
Category	Rivers, Channels & Designated Flood			-122.012077 °
Item	Vegetation & Obstructions			
DWR ID	DWR_NA0035_14_c_2012_36			
Action/Comments				
Inspector Comments: Minimal, scattered obstructions or vegetation. The flow is not impeded.

View of the creek looking downstream towards Suisun Bay from Anderson Dr. Summer 2016.

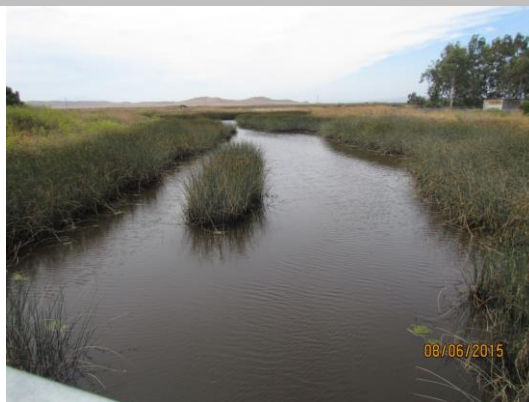
Photo 4 of 4 : CH_2018_NA0035_14_36_20180529_00026.jpg

View of the channel looking downstream. Summer 2015.

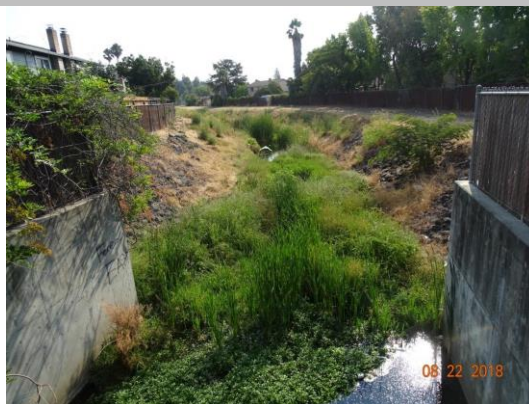
Photo 1 of 4 : CH_2018_NA0035_16_6_20180823_00030.jpg

View of the channel looking downstream. Summer 2018.

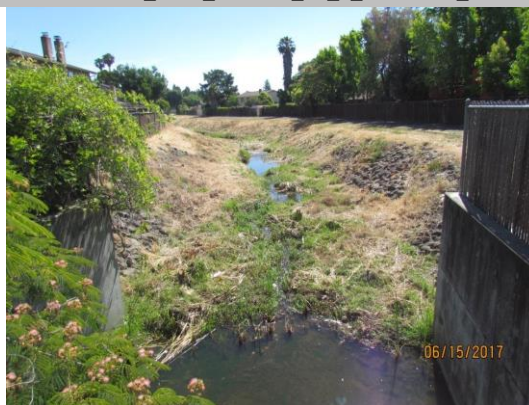
Photo 2 of 4 : CH_2018_NA0035_16_6_20180529_00001.jpg

View of the channel looking downstream. Summer 2017.

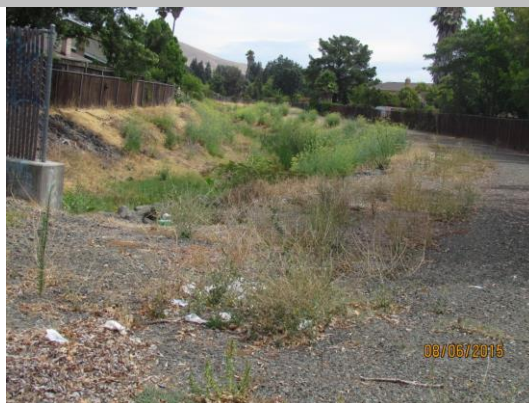
Photo 3 of 4 : CH_2018_NA0035_16_6_20180529_00003.jpg

Looking downstream from N. Texas St. Summer 2015.

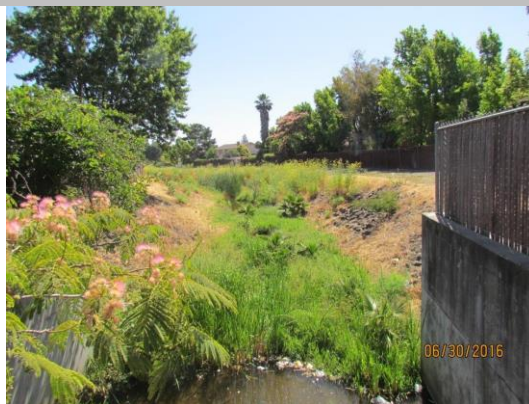
Photo 4 of 4 : CH_2018_NA0035_16_6_20180529_00002.jpg

Rating **	A	Issue No.	6 (cont)	GPS Lat/Long
Issue Type +	Ma	Location *		38.280585 °
Category	Rivers, Channels & Designated Flood			-122.034039 °
Item	Vegetation & Obstructions			
DWR ID	DWR_NA0035_16_c_2012_6			
Action/Comments				
Inspector Comments: Minimal, scattered obstructions or vegetation. The flow is not impeded.

View of the channel looking downstream from N. Texas St. Summer 2016.

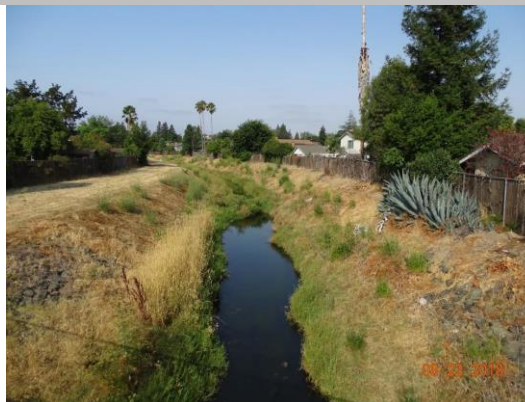
Photo 1 of 3 : CH_2018_NA0035_16_11_20180823_00029.jpg

Inspector Comments: Minimal, scattered obstructions or vegetation. The flow is not impeded. Cactus should be removed.

View of the channel looking upstream. Summer 2018.

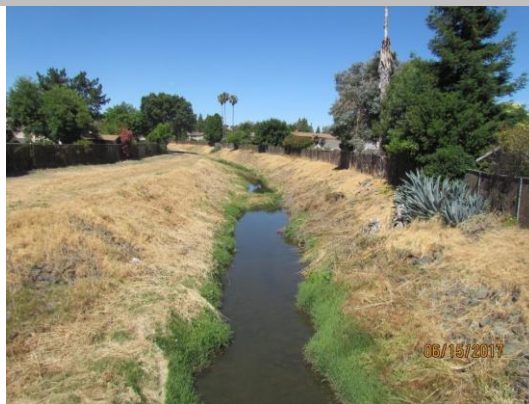
Photo 2 of 3 : CH_2018_NA0035_16_11_20180529_00004.jpg

Inspector Comments: Minimal, scattered obstructions or vegetation. The flow is not impeded. Cactus should be removed.

View of the channel looking upstream. Summer 2017.

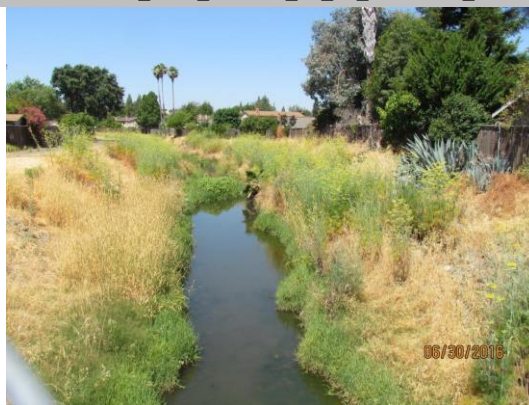
Photo 3 of 3 : CH_2018_NA0035_16_11_20180529_00005.jpg

View of the channel looking upstream from Camrose Ave. Summer 2016.

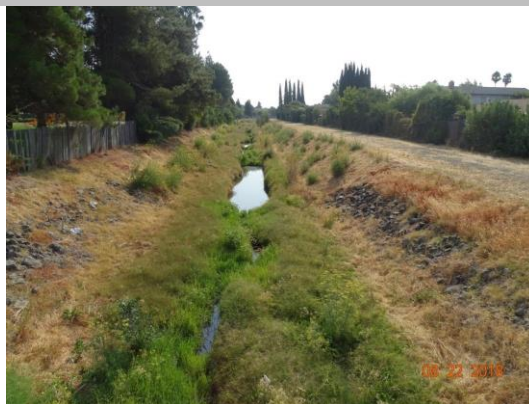
Photo 1 of 4 : CH_2018_NA0035_16_16_20180823_00028.jpg

View of the channel looking downstream. Summer 2018.

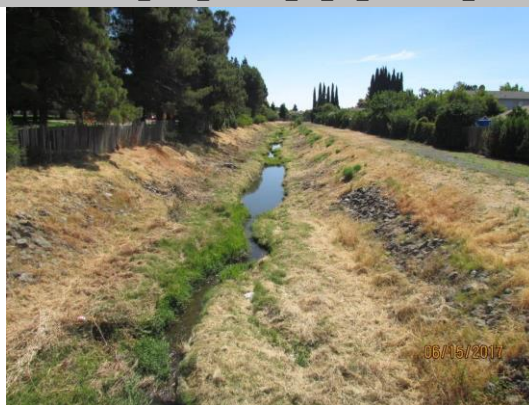
Photo 2 of 4 : CH_2018_NA0035_16_16_20180529_00006.jpg

View of the channel looking downstream. Summer 2017.

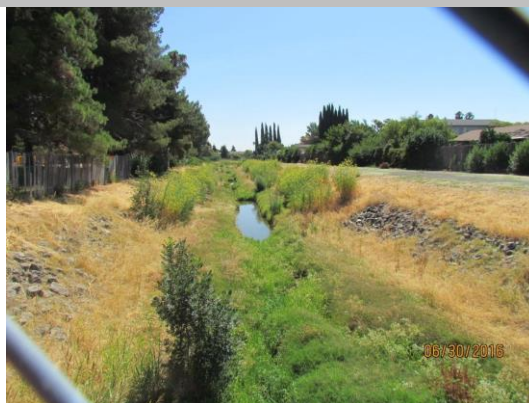
Photo 3 of 4 : CH_2018_NA0035_16_16_20180529_00007.jpg

View of the channel looking downstream from Camrose Ave. Summer 2016.

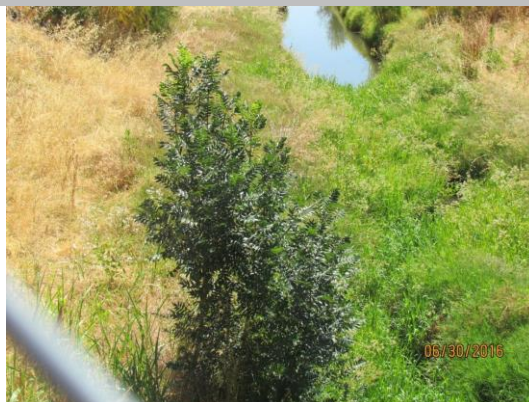
Photo 4 of 4 : CH_2018_NA0035_16_16_20180529_00008.jpg

Check Point / View				
Camrose Ave / Down (cont)				
Rating **	A	Issue No.	16 (cont)	GPS Lat/Long
Issue Type +	Ma	Location *		38.281544 °
Category	Rivers, Channels & Designated Flood			-122.030543 °
Item	Vegetation & Obstructions			
DWR ID	DWR_NA0035_16_c_2012_16			
Action/Comments				
Inspector Comments: Minimal, scattered obstructions or vegetation. The flow is not impeded.

Remove woody vegetation. Summer 2016.

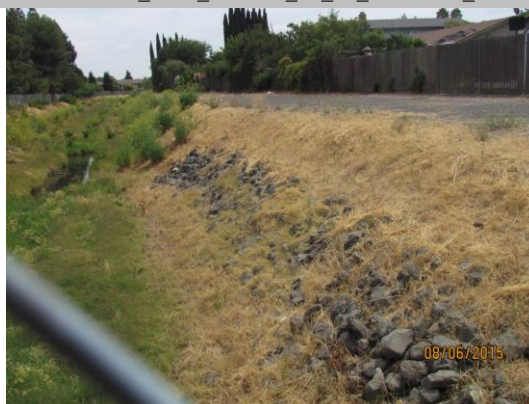
Photo 1 of 1 : CH_2018_NA0035_16_19_20180529_00009.jpg

Check Point / View				
Camrose Ave / Down (cont)				
Rating **	A	Issue No.	19	GPS Lat/Long
Issue Type +	Ma	Location *		38.281546 °
Category	Rivers, Channels & Designated Flood			-122.030544 °
Item	Revetments			
DWR ID	DWR_NA0035_16_c_2012_19			
Action/Comments				
Inspector Comments: Existing riprap protection is properly maintained and is undamaged. Riprap clearly visible.

View of the revetment on the right bank looking downstream. Summer 2015.

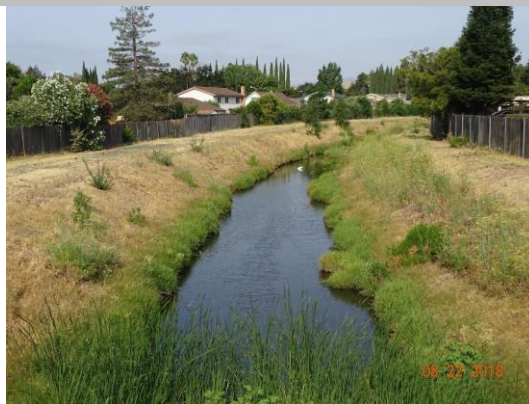
Photo 1 of 4 : CH_2018_NA0035_16_21_20180823_00027.jpg

View of the channel looking upstream. Summer 2018.

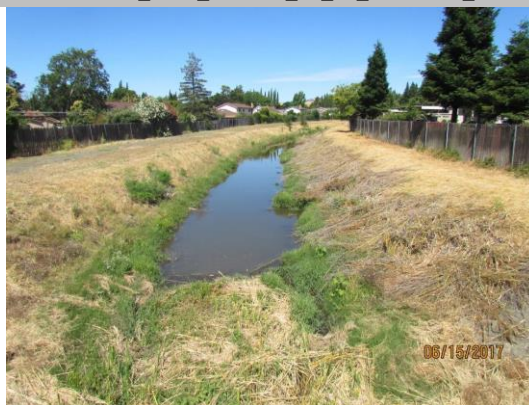
Photo 2 of 4 : CH_2018_NA0035_16_21_20180529_00010.jpg

View of the channel looking upstream. Summer 2017.

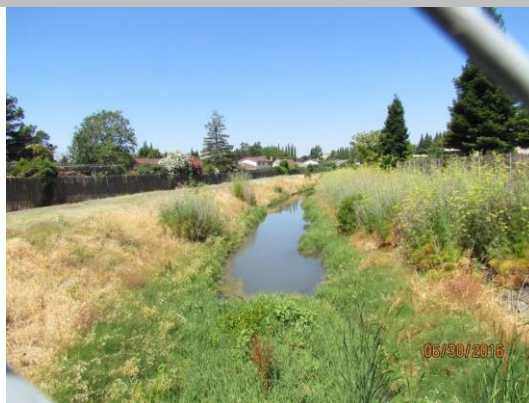
Photo 3 of 4 : CH_2018_NA0035_16_21_20180529_00011.jpg

View of the channel looking upstream from Dover Ave. Summer 2016.

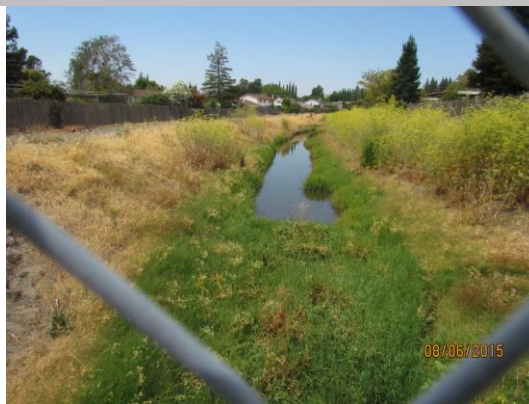
Photo 4 of 4 : CH_2018_NA0035_16_21_20180529_00012.jpg

Check Point / View				
Dover Ave / Up (cont)				
Rating **	A	Issue No.	21 (cont)	GPS Lat/Long
Issue Type +	Ma	Location *		38.280944 °
Category	Rivers, Channels & Designated Flood			-122.025035 °
Item	Vegetation & Obstructions			
DWR ID	DWR_NA0035_16_c_2012_21			
Action/Comments				
Inspector Comments: Minimal, scattered obstructions or vegetation. The flow is not impeded.

Looking upstream from Dover Ave. Summer 2015.

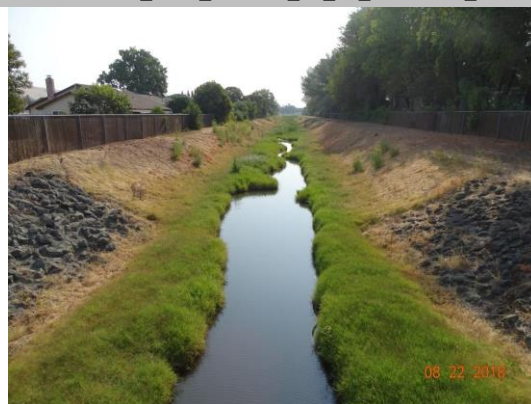
Photo 1 of 4 : CH_2018_NA0035_16_26_20180823_00026.jpg

Check Point / View				
Dover Ave / Down				
Rating **	A	Issue No.	26	GPS Lat/Long
Issue Type +	Ma	Location *		38.280946 °
Category	Rivers, Channels & Designated Flood			-122.025034 °
Item	Vegetation & Obstructions			
DWR ID	DWR_NA0035_16_c_2012_26			
Action/Comments				
Inspector Comments: Minimal, scattered obstructions or vegetation. The flow is not impeded.

View of the channel looking downstream. Summer 2018.

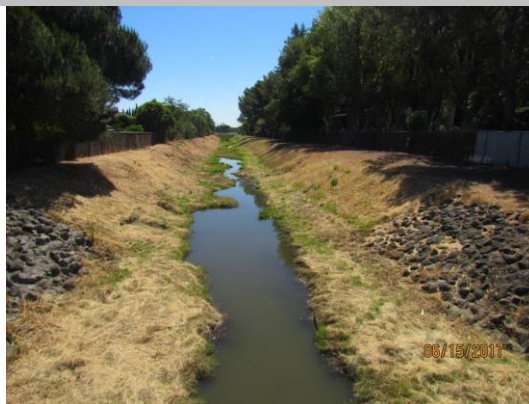
Photo 2 of 4 : CH_2018_NA0035_16_26_20180529_00013.jpg

View of the channel looking downstream. Summer 2017.

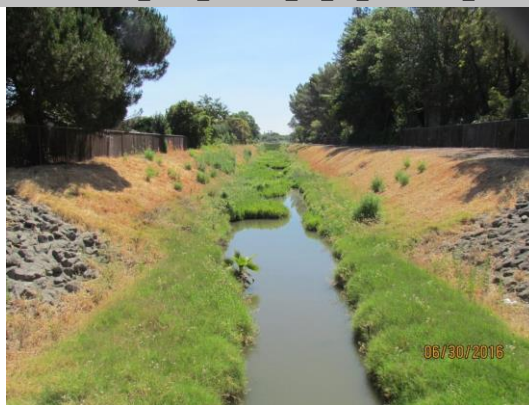
Photo 3 of 4 : CH_2018_NA0035_16_26_20180529_00014.jpg

View of the channel looking downstream from Dover Ave. Summer 2016.

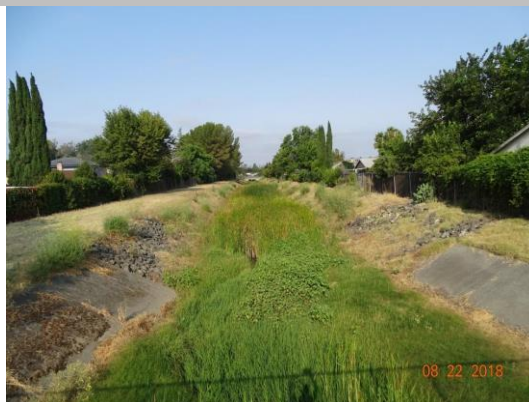
Photo 1 of 4 : CH_2018_NA0035_16_31_20180823_00025.jpg

Check Point / View				
Gulf Dr / Up				
Rating **	M	Issue No.	31	GPS Lat/Long
Issue Type +	Ma	Location *		38.281002 °
Category	Rivers, Channels & Designated Flood			-122.020570 °
Item	Vegetation & Obstructions			
DWR ID	DWR_NA0035_16_c_2012_31			
Action/Comments				
Inspector Comments: Vegetation growth (such as cat tails, bull rushes, bushes or saplings) or other obstructions block approximately 25% of the capacity.

View of the channel looking upstream. Summer 2018.

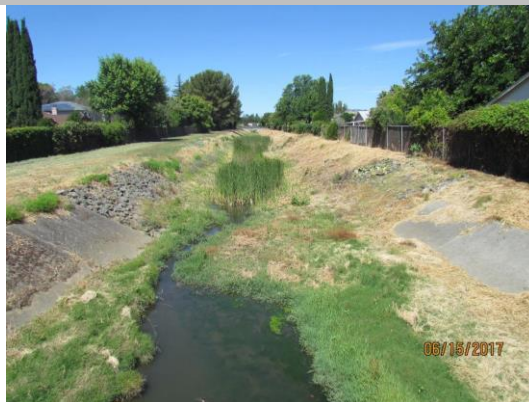
Photo 2 of 4 : CH_2018_NA0035_16_31_20180529_00016.jpg

View of the channel looking upstream. Summer 2017.

Check Point / View				
Gulf Dr / Up (cont)				
Rating **	M	Issue No.	31 (cont)	GPS Lat/Long
Issue Type +	Ma	Location *		38.281002 °
Category	Rivers, Channels & Designated Flood			-122.020570 °
Item	Vegetation & Obstructions			
DWR ID	DWR_NA0035_16_c_2012_31			
Action/Comments				
Inspector Comments: Vegetation growth (such as cat tails, bull rushes, bushes or saplings) or other obstructions block approximately 25% of the capacity.

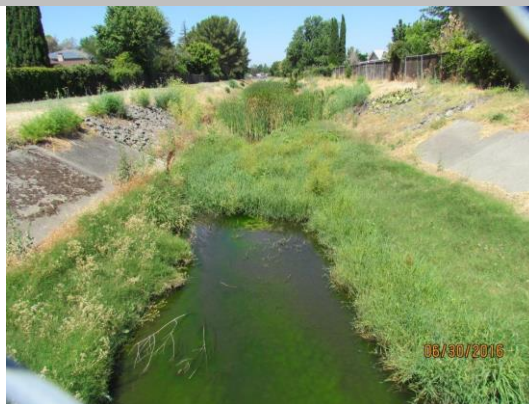
Photo 3 of 4 : CH_2018_NA0035_16_31_20180529_00017.jpg

View of the channel looking upstream from Gulf Dr. Summer 2016.

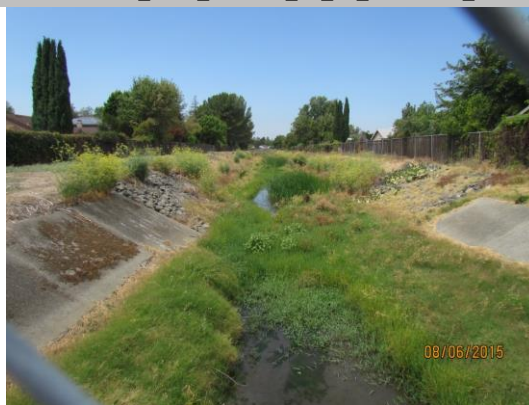
Photo 4 of 4 : CH_2018_NA0035_16_31_20180529_00018.jpg

Looking upstream from Gulf Dr. Summer 2015.

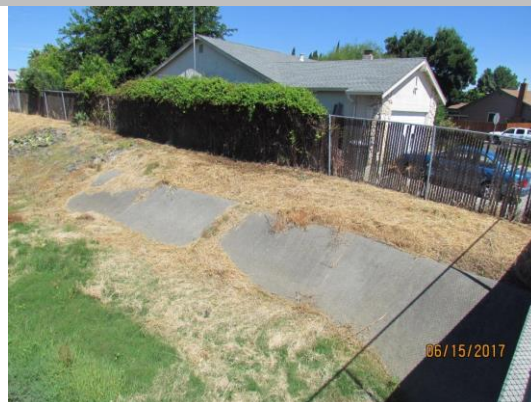
Photo 1 of 1 : CH_2018_NA0035_16_41_20180529_00022.jpg

Check Point / View				
Gulf Dr / Up (cont)				
Rating **	A	Issue No.	41	GPS Lat/Long
Issue Type +	Ma	Location *		38.281002 °
Category	Rivers, Channels & Designated Flood			-122.020570 °
Item	Concrete Surfaces			
DWR ID	DWR_NA0035_16_c_2017_41			
Action/Comments				
Inspector Comments: Concrete surface appears to be in good condition with no visible deficiencies.

View of concrete surface on left bank, looking upstream. Summer 2017.

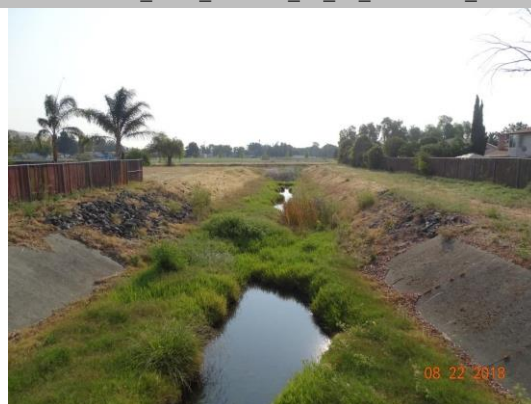
Photo 1 of 4 : CH_2018_NA0035_16_36_20180823_00024.jpg

Check Point / View				
Gulf Dr / Down				
Rating **	A	Issue No.	36	GPS Lat/Long
Issue Type +	Ma	Location *		38.280937 °
Category	Rivers, Channels & Designated Flood			-122.020629 °
Item	Vegetation & Obstructions			
DWR ID	DWR_NA0035_16_c_2012_36			
Action/Comments				
Inspector Comments: Minimal, scattered obstructions or vegetation. The flow is not impeded.

View of the channel looking downstream. Summer 2018.

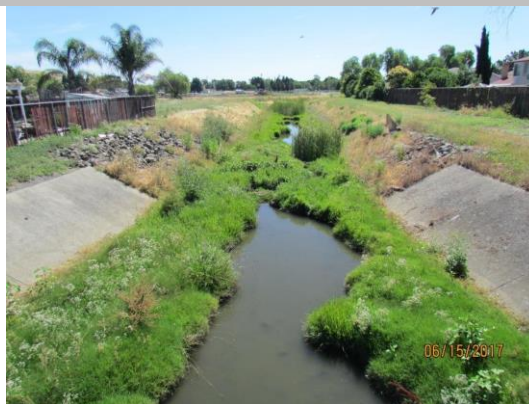
Photo 2 of 4 : CH_2018_NA0035_16_36_20180529_00019.jpg

View of the channel looking downstream. Summer 2017.

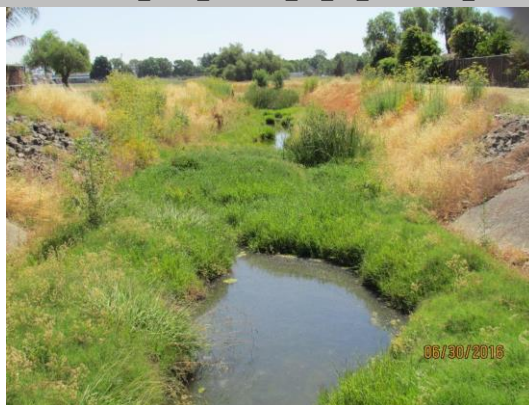
Photo 3 of 4 : CH_2018_NA0035_16_36_20180529_00020.jpg

View of the channel looking downstream from Gulf Dr. Summer 2016.

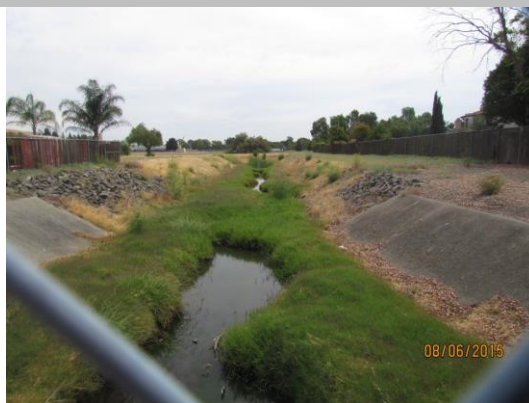
Photo 4 of 4 : CH_2018_NA0035_16_36_20180529_00021.jpg

Looking downstream from Gulf Dr. Summer 2015.

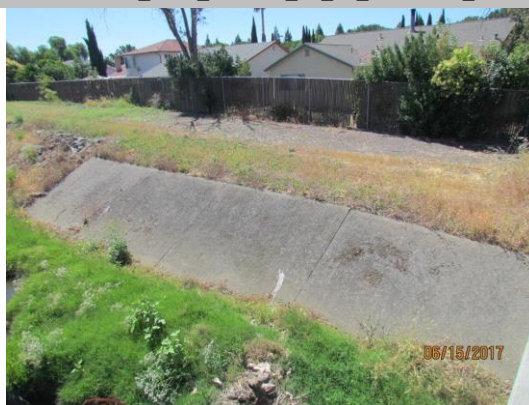
Photo 1 of 1 : CH_2018_NA0035_16_42_20180529_00023.jpg

Rating **	A	Issue No.	42	GPS Lat/Long
Issue Type +	Ma	Location *		38.281002 °
Category	Rivers, Channels & Designated Flood			-122.020570 °
Item	Concrete Surfaces			
DWR ID	DWR_NA0035_16_c_2017_42			
Action/Comments				
Inspector Comments: Concrete surface appears to be in good condition with no visible deficiencies.

View of concrete surface on right bank, looking downstream. Summer 2017.
